LAKE VICTORIA WATER AND SANITATION INITIATIVE
FAST TRACK CAPACITY BUILDING PROGRAMME FOR UTILITIES

Rapid Assessment Report

August 2008

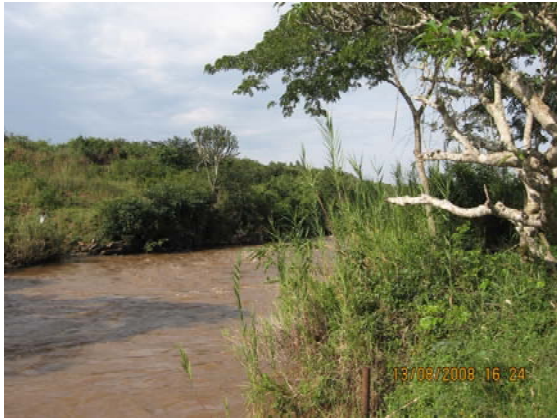
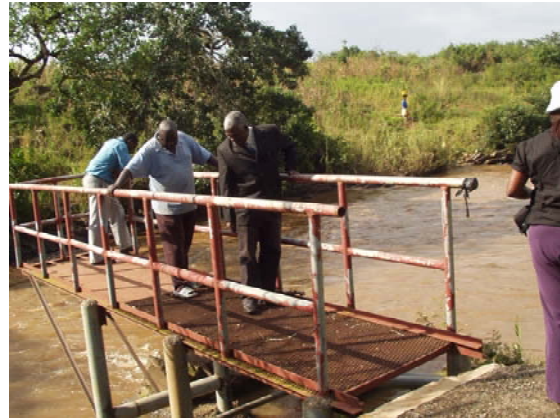
Plate 1: Yala River Water intake

- **River Yala Raw Water Intake and Treatment Works.** Raw water is abstracted from Yala River (Plate 1) via two GI pipes of DN 75 mm and about 20 m long. There were two installed raw water pumps (NORMAFLO manufactured by Denorco) of capacity 44 m³/hr but only one was functional with one needing the foot valve to be replaced (Plate 2). A newly purchased pump was also lying in the pump house awaiting installation. The electro-mechanical condition of the pumping units were in poor condition and there was no evidence of planned preventive maintenance (PPM) being done.

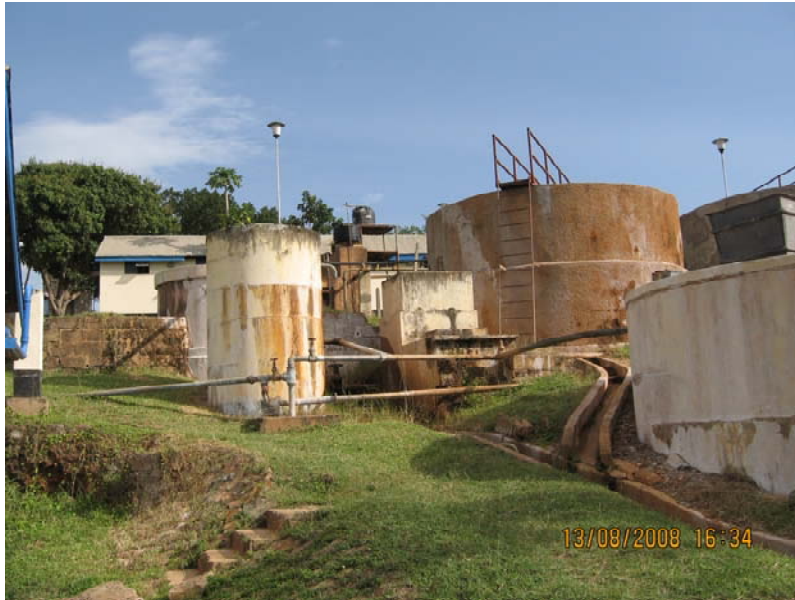
Plate 3: Overview of the treatment plant

- **Water Treatment Units:** The treatment process is comprised of the conventional treatment: raw water pumping, mixing tanks, composite filters (clarification/filtration) and disinfection (Plate 3). The treatment process is ineffective and most units are non-functional. At the time of the visit, it was observed that there was a mismatch between raw water production capacity and mixing chambers resulting into overflow of alum/soda ash dozed water. The units were poorly kept, leaking and needed painting.

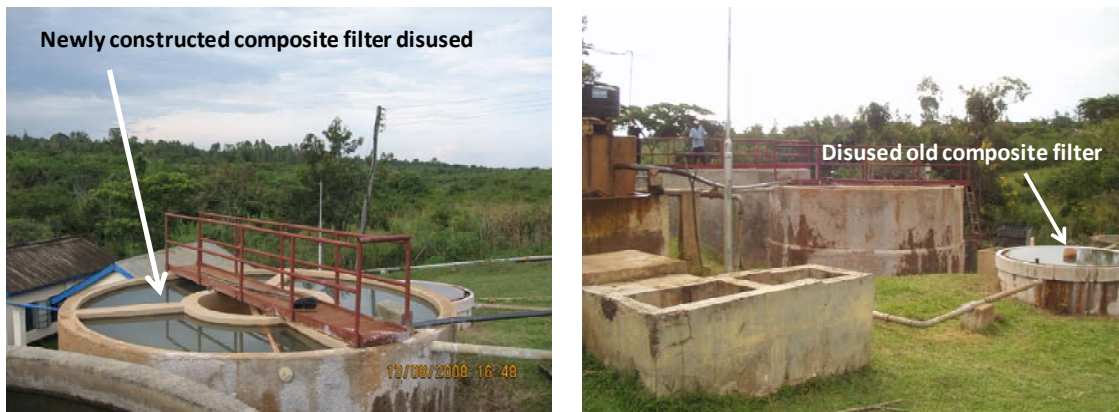
Plate 4: Filter Composite units

The two composite filters were also not working although one had just been constructed less than a year ago (Plate 4). The failure of this filter is attributed to the poor design of the filter nozzles as well as the use of poor sand quality. The failure of the composite units is further a result of improper dosing of alum resulting in floc formation occurring in the filter and resulting in faster clogging of the filter. Furthermore, the staff on site did not seem to understand the need for backwashing of the filters or desludging of the clarification units.

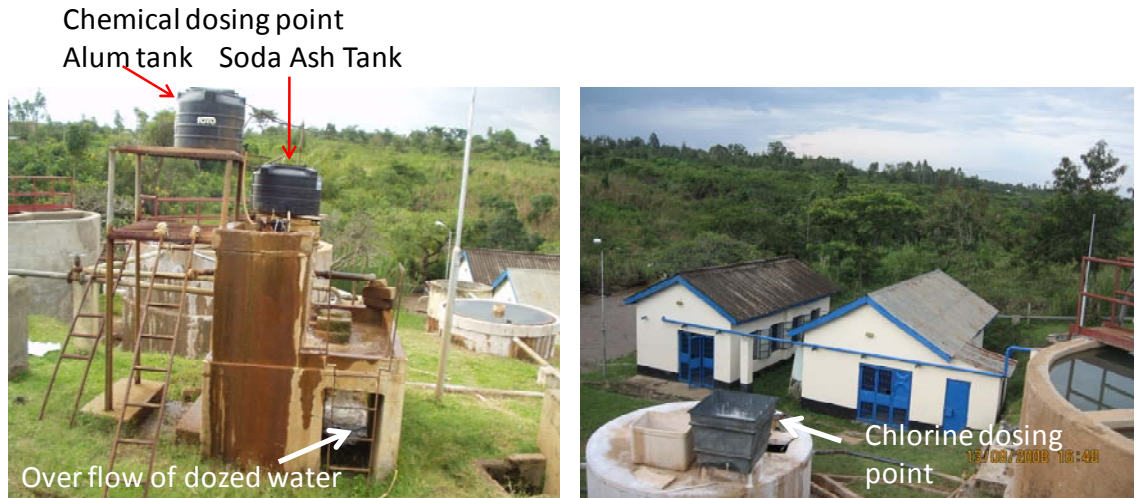
Plate 5: Chemical dosing points

The chemical dozers were not functioning properly and there was no clear guideline for chemical dosing. About 40% of the raw water abstracted was being wasted in the treatment units and returned to the river (Plate 5).

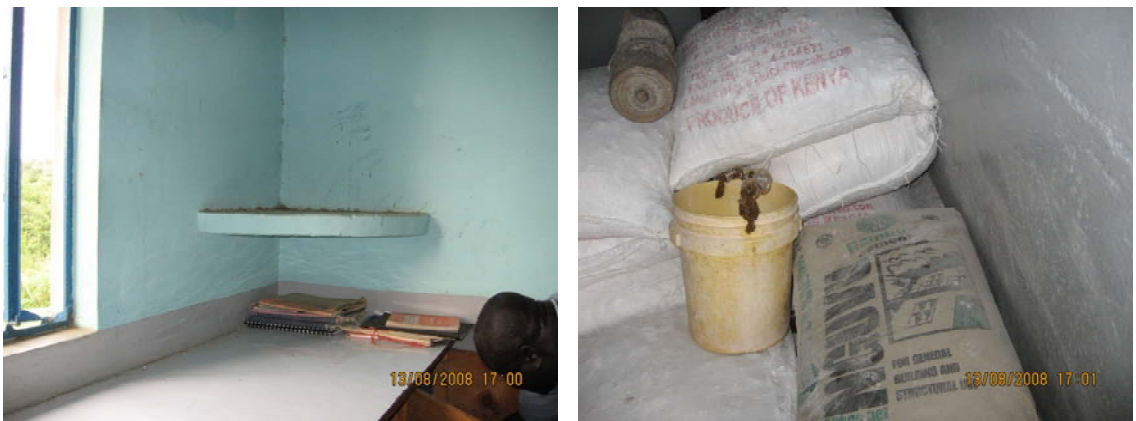
Plate 6: Laboratory and bulk chemical storage

There was no process control or quality control system in place hence no records on the quality of raw water abstracted or the treated water pumped. The laboratory was apparently bare and no staff within SIBO are trained to handle quality issues. The chemical storage was poor with chemical bags put flat on the floor.

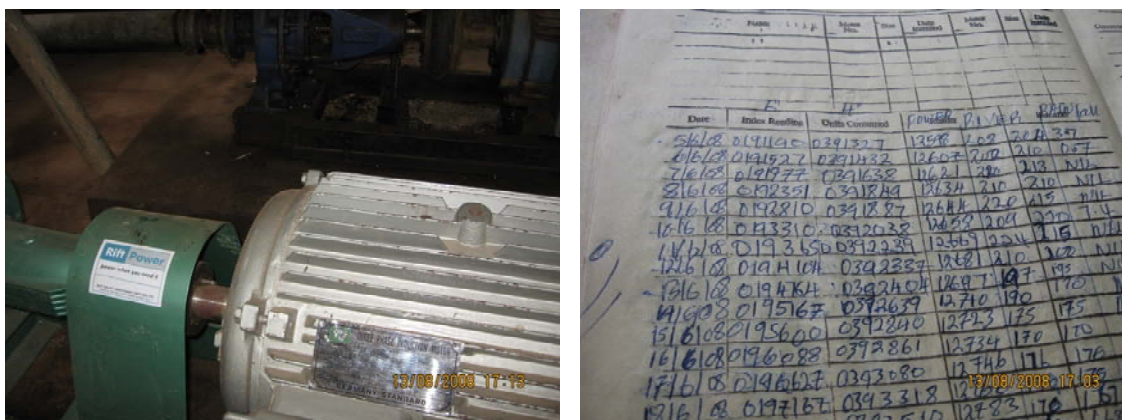
Plate 7: Motor of one of the pumps and records of pump hours and power consumption

- **Treated Water Pumps:** There were two high lift pumps with one operational (40 m³/h) and a new one awaiting installation (50 m³/h) (Plate 7). Water is pumped from two old clear water tanks of capacity 45 m³ each. Frequent pump breakdowns were reported and is mainly attributed to lack of PPM. There were some records being taken at the plant covering power consumption and water pumped to the reservoir. However, there was no raw water bulk meter and records were based on pumping rates and hours (Plate 7).

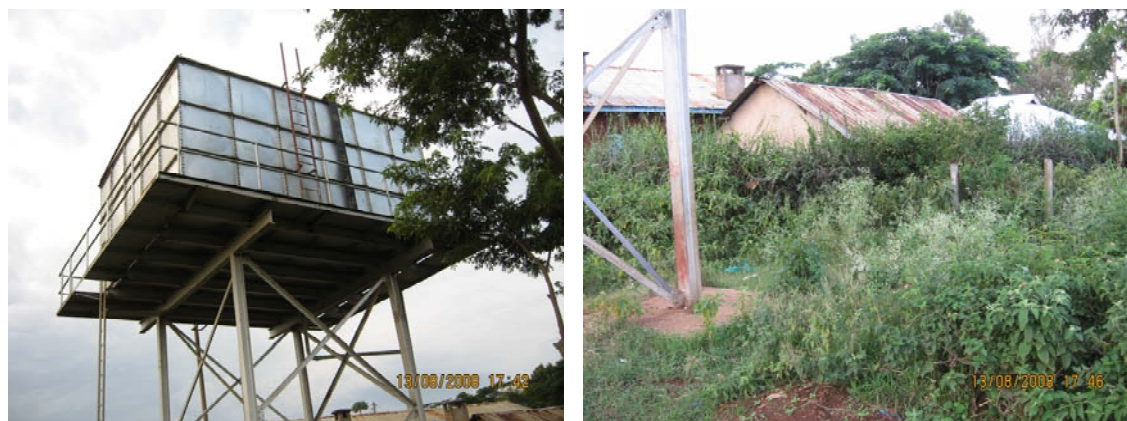
Plate 8: Elevated reservoir for Bondo Water Supply area

- Storage Tanks:** Water is pumped to an elevated backwash water tank (50 m³) and the elevated steel tank (90 m³) near the main hospital via transmission mains. The tank had a level recorder. However, this storage tank is being by-passed and no explanation was given by the management team. It was apparent that this reservoir has not been utilized for a long time (confirmed by the Scheme Manager) but appears to be in a good condition. Before storing water for distribution in the reservoir, it should be cleaned and disinfected and checked for leakage and for any structural damage. Direct pumping into the system results into high pressures increasing frequency of bursts and leaks which result into low pressures and service interruption in some parts of the network. The reservoir area was poorly kept with no fence to ensure security. The grass had also overgrown into a bush.

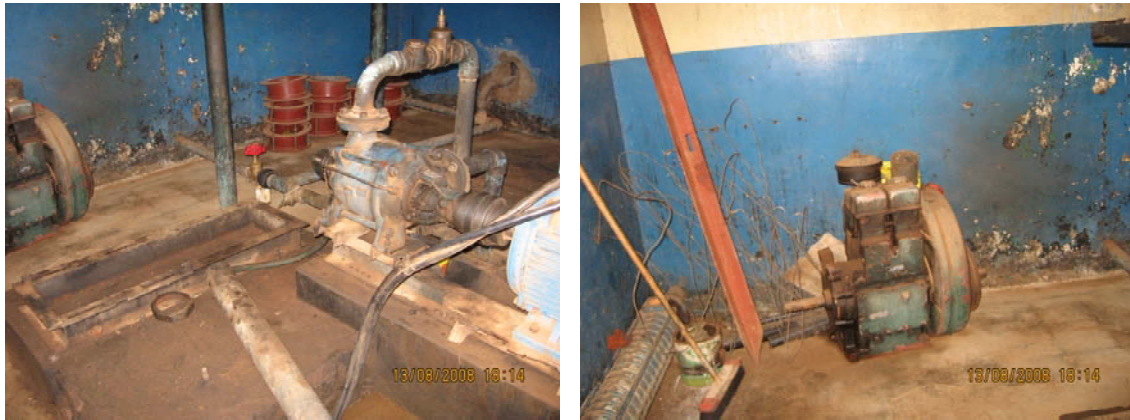
Plate 9: Bondo Water Booster Station

m³/h and pumping head of 50 m. At the time of the visit the pumps were not working due to insufficient water in the storage sumps (Plate 9). The electro-mechanic equipment were in poor state. There is need to refurbish this booster as it is now serving very sensitive customers including the Prime Minister's residence.

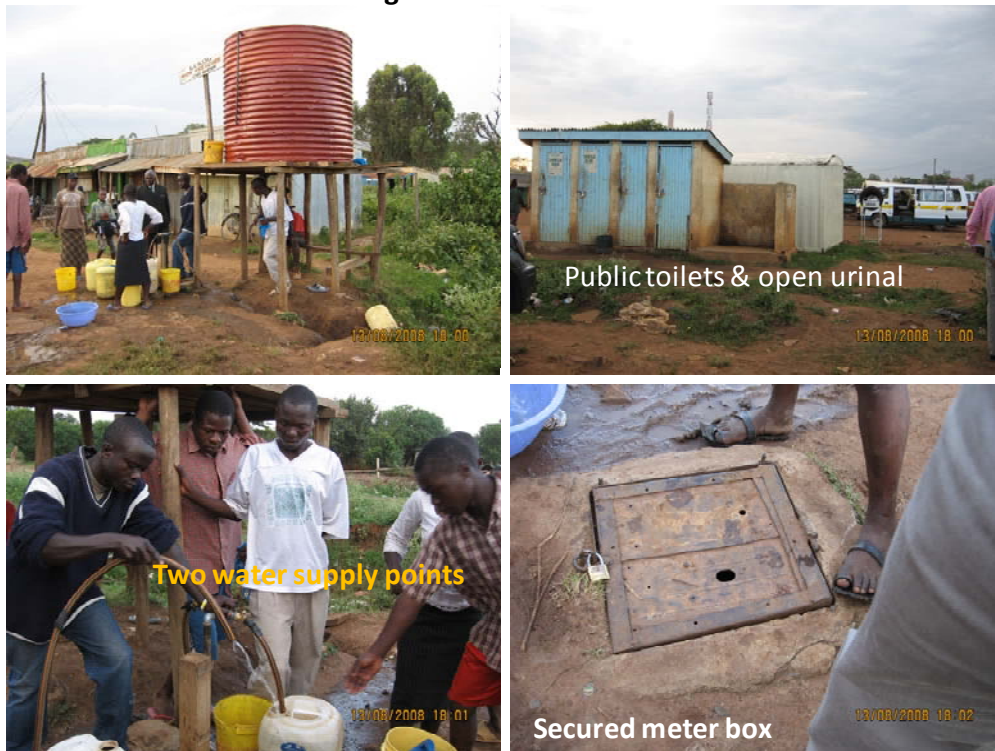
Plate 10: one of the Water Distribution points in Bondo town

- **Distribution points:** There are no kiosks in Bondo however some public distribution points exist. One point was visited and is run by a group of youth and supplies a public toilet and car washing bay. The meter box was tightly secured and the ET could not establish if the meter in place is working or not. The general sanitation of the stand post was poor. It was also apparent that there were two water supply points (Plate 10).

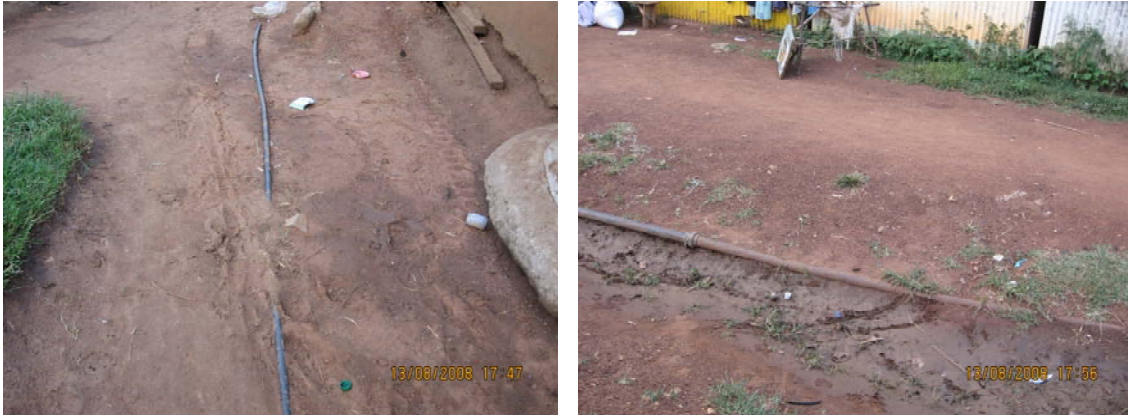
Plate 11: Pipes laid on the surface in Bondo town

- **Distribution network:** Some of the mains are laid on the surface and this was seen in various parts of the network (Plate 11). There appears to be no standard on the pipe depth. Some efforts have been made to make some mains extensions but there was no proper data available at the Bondo office on what has been done.

No.	Item	Present condition	Required works	Estimated Costs (USD \$)
Water Distribution				
1	Pipelines & Valves	No network maps No Asset register & failure records to ascertain condition Some pipes were visible above ground Frequent pipe burst reported	Network Distribution maps Need for Asset register Database for data capturing Replacement of old AC mains	15,000 15,000 5,000 30,000
2	Storage Reservoirs	Good but by-passed Bushy surrounding Poor sanitation	Bulk meters Fence to keep off intruders Toilet & quarters for attendant	1,000 1,000 2,000
3	Booster Stations	One pump operational Electro-mechanical equipment in poor condition Receives insufficient water and increasing plant downtime	Procure a second standby pump Refurbish all electro-mechanical equipment Ensure reservoir is in use to guarantee maximum flow to the booster station	15,000 5,000
4	Customer service Lines	Inadequate depth for some lines Low metering efficiency (53%) Inadequate meter management High number of leaks reported	Relay pipes which are on the surface to the right depth	10,000

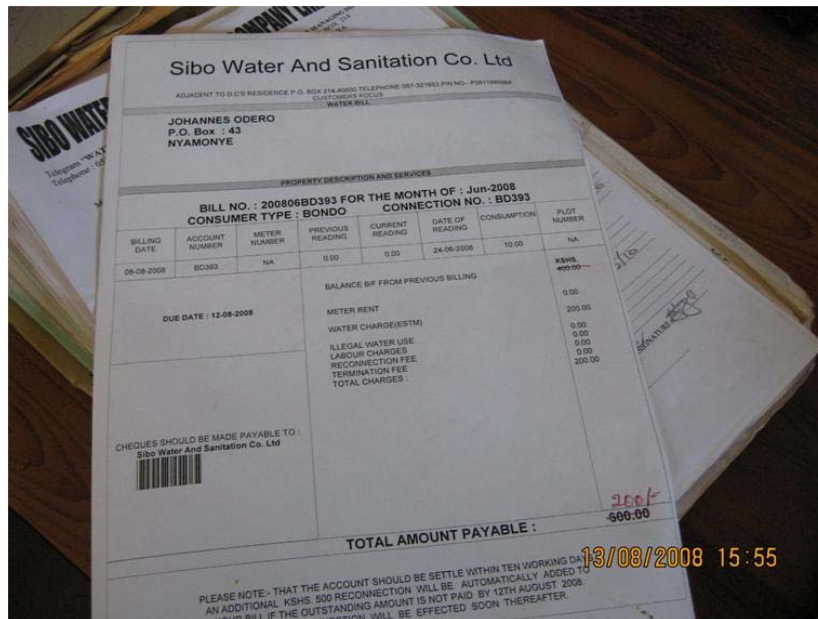
- **Billing System:** The *customer database* is manual and the customer details are captured in consumer ledger books. The current system is not comprehensive due to the difficulties experienced in data entries. The *billing system is computerized* using the Water Flex billing software (Plate 13). There are many errors from the current computerized billing system due to wrong data capture and billing non-existent services. The errors are also due to the lack of competence of staff and poor co-ordination between the operational office at Bondo and management staff at SIBO Head office in Siaya. However some reports like consolidated arrears and other management reports cannot be generated from the system.

Plate 13: Example of printed water bill which has amount due crossed out

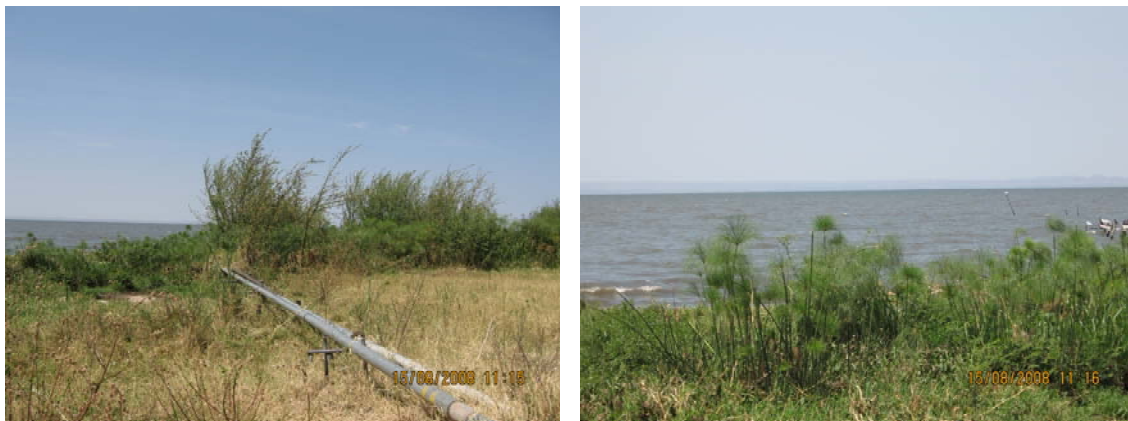
Plate 15: Guta raw water abstraction point

- **Raw Water Intake & Guta Pumping Station:** Raw water is abstracted from Lake Victoria via two GI pipes of DN 150 mm and about 100 m long into the lake. Water is pumped directly to Migungani Booster without treatment. The communities tapping water directly from the pumping mains are at great risk of water borne diseases. Like all intakes around the shores of Lake Victoria, the Guta intake was hit by the drop of lake water levels since 2005, and poor water quality. The intake was extended 150 meters into the lake and floating pumps installed to mitigate against the dropping lake levels (Plate 14).

The raw source is heavily polluted (Faecal coliform counts up to 4800/100 ml) due to the many Hippos within the lake and the cows that graze within the vicinity and drink water from close by. There are two installed surface raw water pumps whose capacity was not known and one floating pump inside the lake (Plate 15).

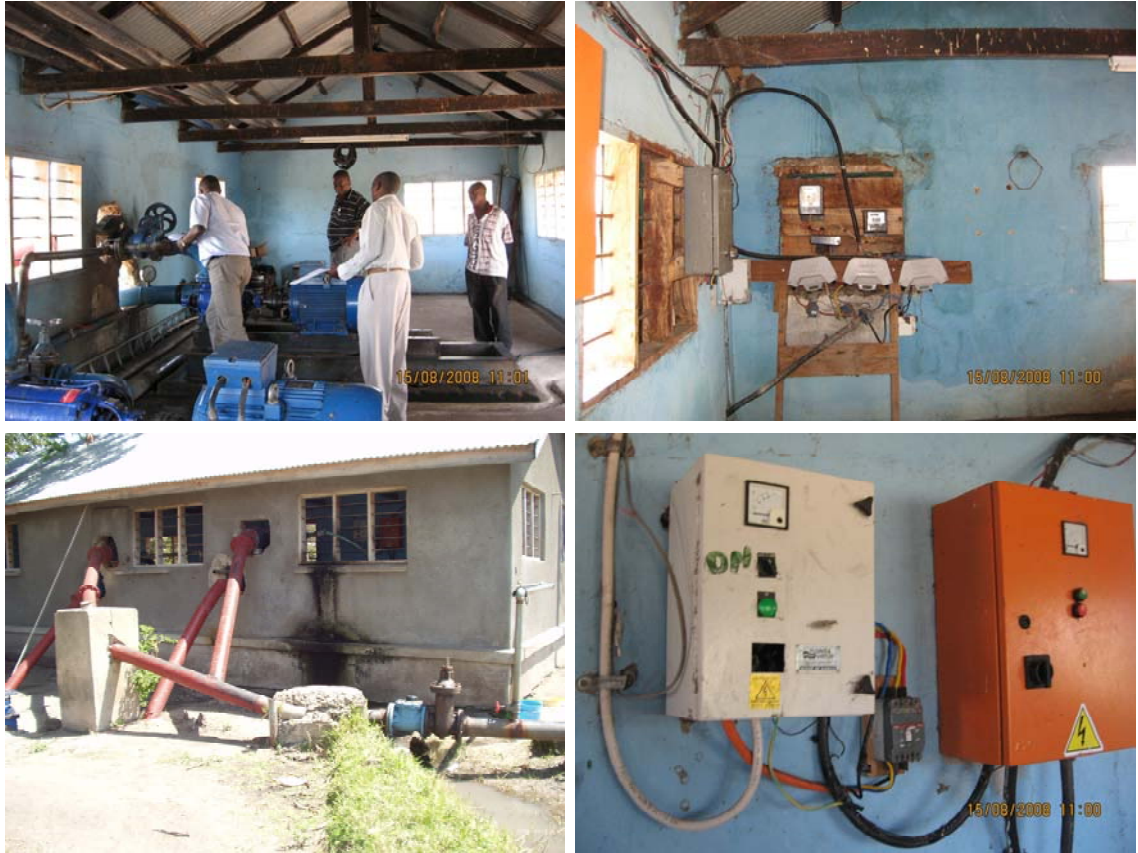
Plate 16: Raw water pumps and electrical panel units at Gupta pumping station

The mechanical condition of the pumping units were in fair condition but the electrical units need attention. The energy consumption was observed to be very high with energy efficiency of about 1.7 kwh/m³. This is due to the small size of transmission mains and so many bends at pumping house outlets resulting into high head losses. The various booster stations in the distribution network due to the hilly topography of Bunda also

increase energy costs. The total monthly electricity pumping costs is about T.Shs. 8 million which is far more than the monthly water sales of about T.Shs. 2.5 million raising challenges of system sustainability. According to the area manager, new pumps have been procured for the newly proposed Nyabehu intakes & treatment works.

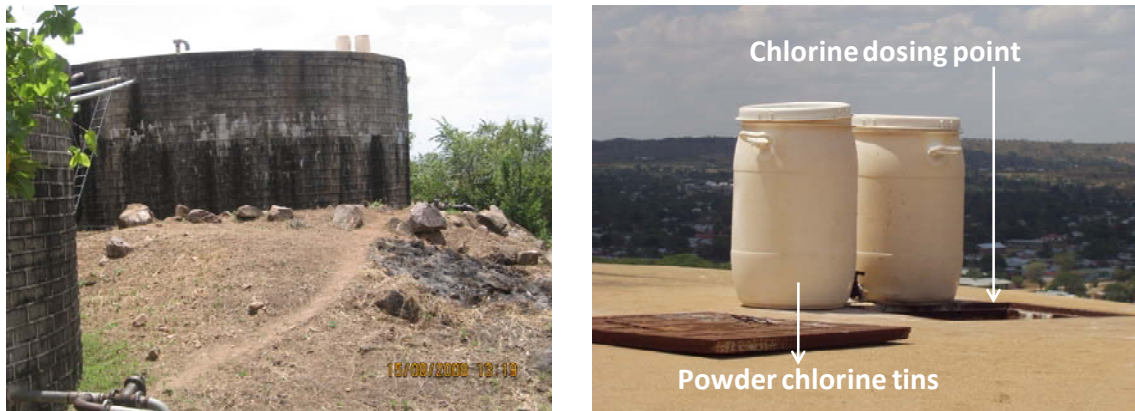
Plate 17: Bomani Reservoir and chlorine dosing point

- Water Treatment Units:** There is no water treatment in Bunda apart from disinfection by chlorine dosing at the Bomani hills main reservoirs. There were no dosing records and the effectiveness of chlorine dosing was doubtful (Plate 16).

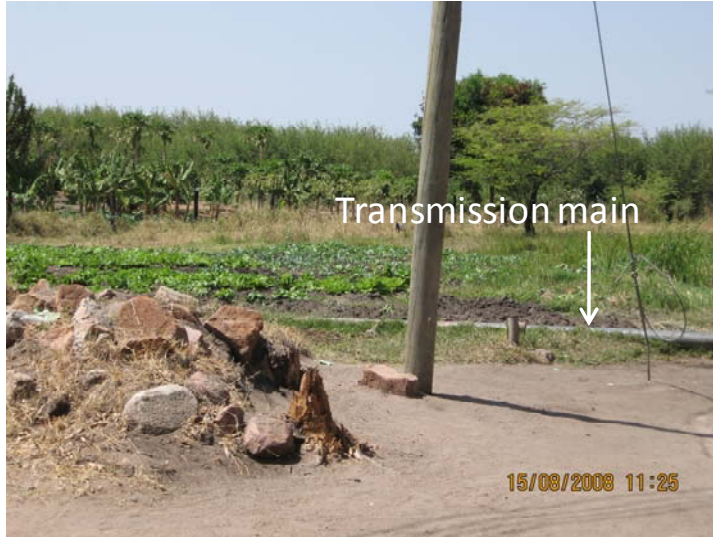
Plate 18: Transmission main leaving Gupta Pumping Station

- Transmission Mains:** There is one rising main of size 150 mm uPVC, with a total length of about 22 km (Plate 17). Water production is measured by the bulk meter installed at Guta pumping station. There are also two bulk meters at the Migungani Booster stations along the transmission mains. There were no records for bulk meter calibration raising doubts on their accuracy. Frequent bursts were reported on the transmission mains.

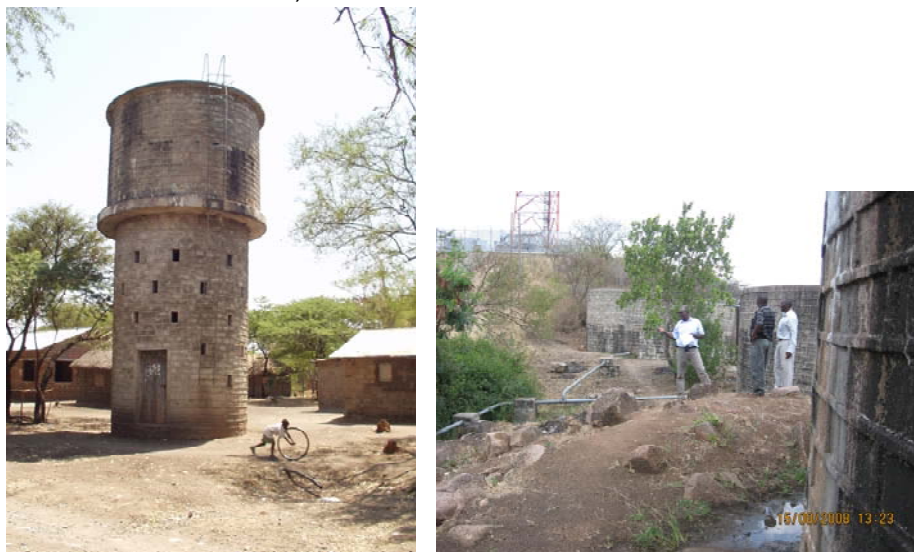
Plate 19: Water tower in Gupta Village and Bomani Reservoirs

- Storage Tanks:** There are various small water towers at Guta (45 m³), Tairo (45 m³), Migungani (45 m³), Mugaja (45 m³), Manyamanyama (90 m³), and Mishushi (135 m³) in the water distribution systems with the main reservoirs (3 No. each of capacity 225 m³) located at Bomani Hills (Plate 18). The tanks are made of concrete blocks and are fairly in sound condition with minor surface cracks. They all lack water levels and frequently experience overflows increasing physical water losses. The main storage reservoirs at Bonda hill are suitable to supply areas within pressure zone A (below 1240 m asl). A new tank has been proposed at Kaswaka Hills (1300 m asl) to serve pressure zone B (between 1240 & 1300 m asl).

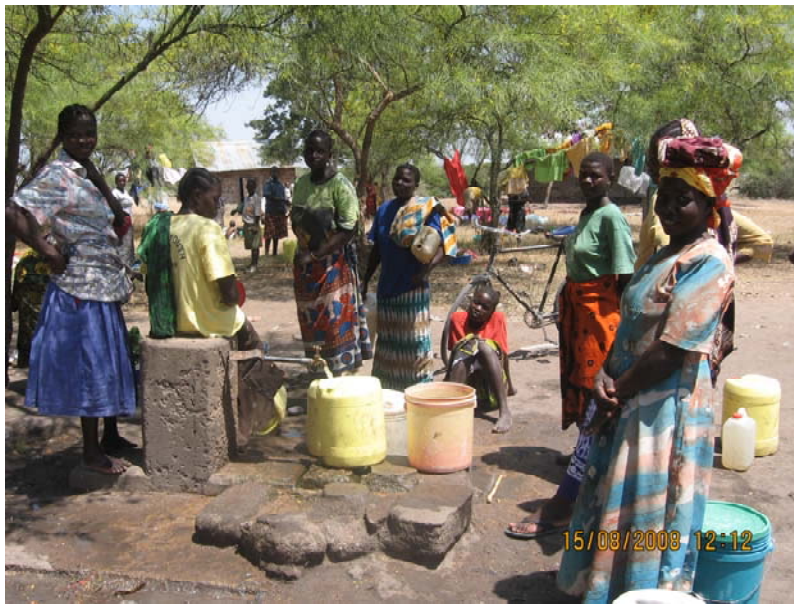
Plate 20: Water Distribution point at Tairo Primary School

- The Distribution Network:** The distribution network is divided into two pressure zones A and B. Zone A with about 400 connections is comprised of Ikuzu road, Ukerewe road, Kabarimu, Kiabakari road, Balili, Tairo and Guta villages. Zone B has about 600 connections and is comprised of Bunda stoo, Sabasaba road, Posta road, Nyasura Boma quarters and Boma road. Manyamanyama hospital that is going to be connected soon will also be part of Zone B. Most of the network is old with frequent leaks and bursts. Piped water service coverage is estimated at 18%. Metering efficiency is low at 40% resulting into water wastage and high non-revenue water (NRW) estimated at 60%. For example one public kiosk at Tairo primary school was being charged a flat rate of T.Shs 8,000 yet it sells about 20,000 jerry cans of water per month at T.Shs 100 per 20 litre jerrycan. There are no maps indicating the distribution network layout which complicates network operation and management. The field team could not trace pipelines that used to supply places like Manyamanyama water tower. The network mainly comprises of AC, GI, PE and uPVC pipes ranging in diameter from 25 to 100 mm. It is estimated that the total length of the existing main distribution network is approximately 27 km. The operations and maintenance team lack sufficient tools to effectively carry out their field tasks. Water supply is intermittent and most areas do not receive water at all.

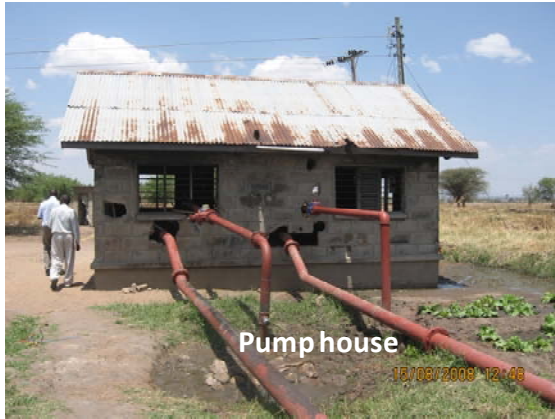
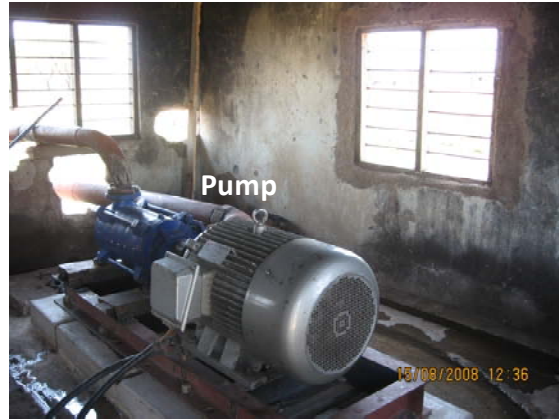
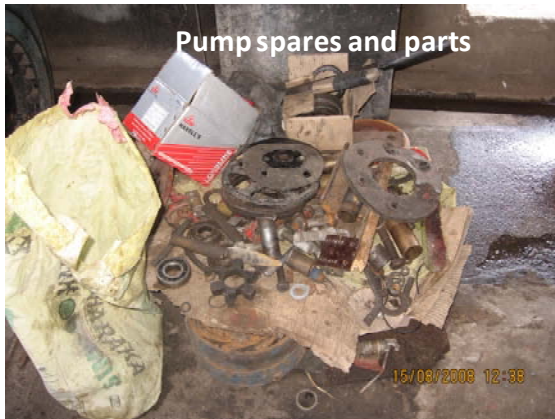
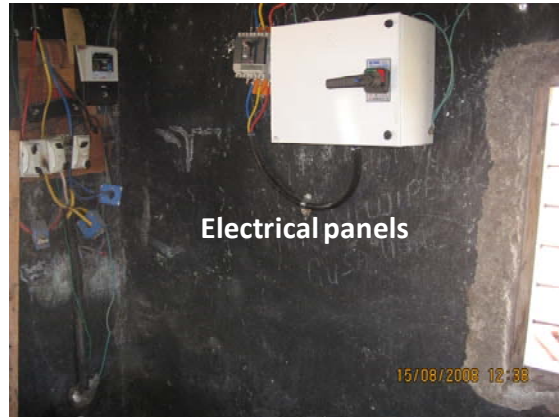
Plate 21: Migungani Booster Station

- Water Booster Stations:** There are three booster stations (Migungani, Mugaja & Ushashi) within the water supply system. Migungani is the biggest booster station with two pumps ($Q = 70 \text{ m}^3/\text{h}$, $H = 90 \text{ m}$) and a storage tank of 45 m^3 . It pumps water along the transmission line to Bomani Hill reservoirs (Plate 20). However, the pumps are idle most of the time due to inadequate water supply from Guta intake. There is a mismatch between the Guta intake pumps and the Migugani booster station pumping capacity that need urgent attention to reduce on water supply shortages. There was apparent evidence of overflows around the booster station.

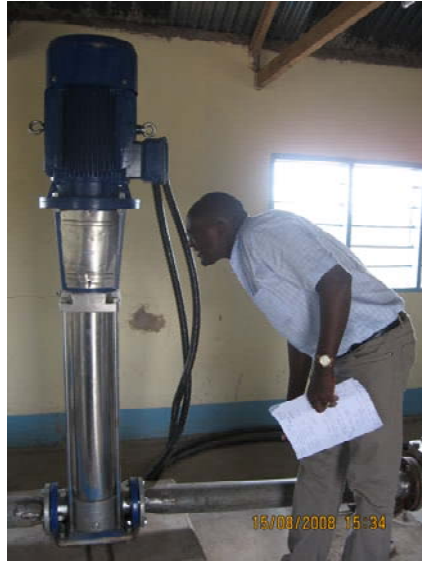
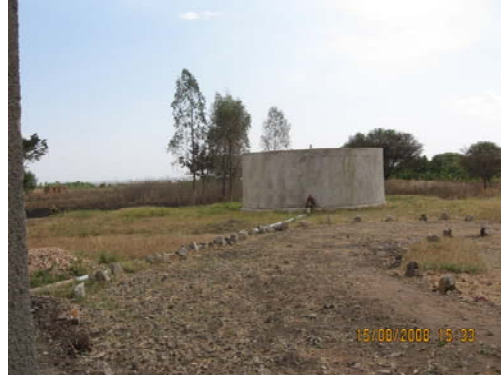
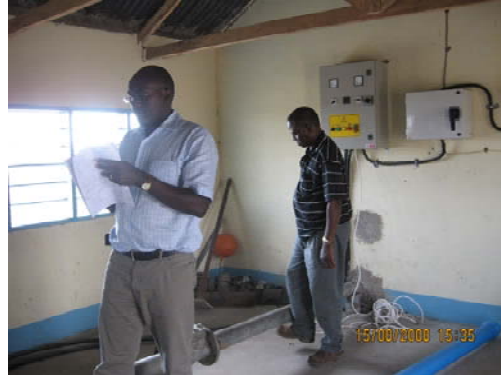
Plate 22: Mugaja Booster Station with newly installed vertical pump

The Mugaja booster station is newly refurbished with one new vertical pump ($Q = 32 \text{ m}^3/\text{h}$, $H = 138 \text{ m}$) and a suction reservoir of 45 m^3 (Plate 21). It receives water from the Bomani reservoirs and is meant to supply the Manyamanyama water tower and the surrounding areas. At the time of the visit the pump was not in operation as the old pumping main to Manyamanyama was still being traced. The Ushashi booster has one pump and pumps water to Mishishi reservoir (135 m^3). Water supply to the station is on and off. The pump house was in a messy state and the pump attendant was found cooking right next to the new pump (Plate 22).
