LAKE VICTORIA WATER AND SANITATION INITIATIVE
FAST TRACK CAPACITY BUILDING PROGRAMME FOR UTILITIES

Rapid Assessment Report

August 2008

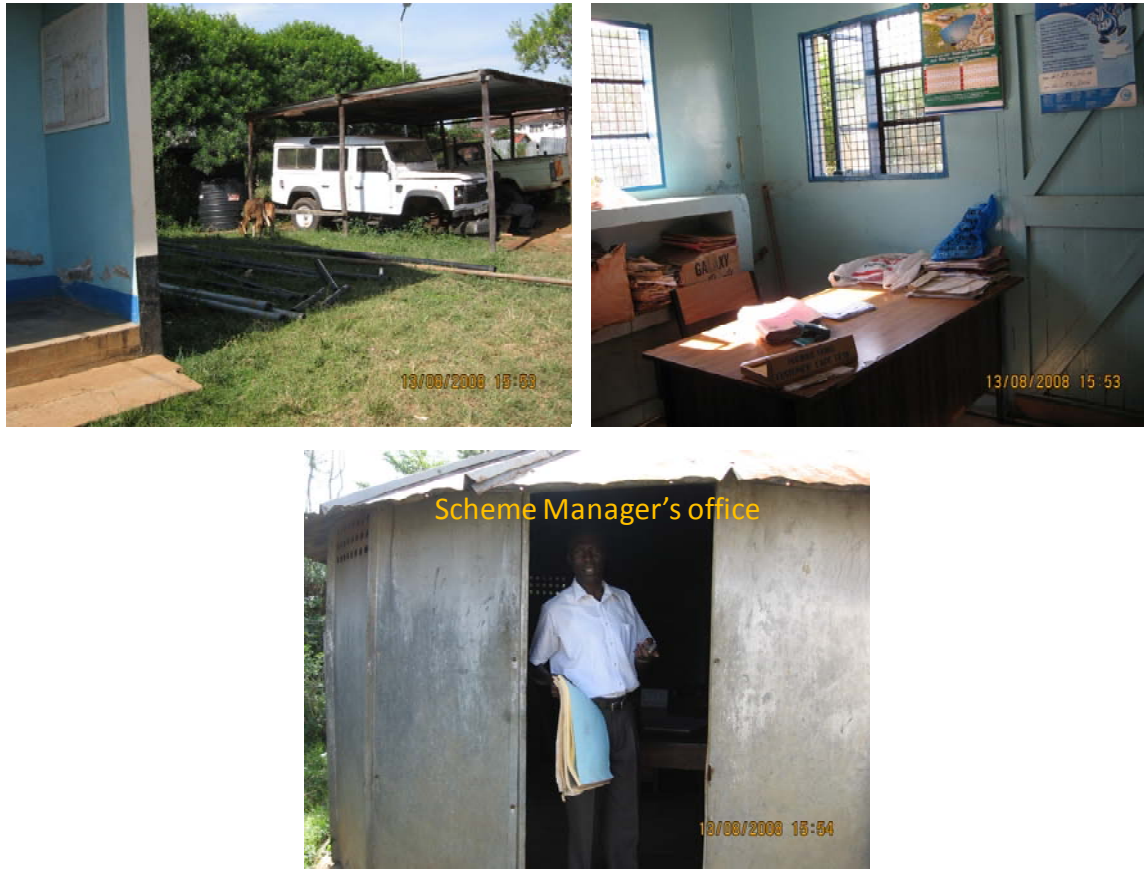
Plate 12: General appearance of Bondo Water Supply Scheme

Under Commercial and Customer Care Services, the ET found that there were some systems in place but most were not comprehensive enough with important information not being recorded. The general appearance of Bondo Water Supply Offices is poor with the ambience of the place not very good. Offices need some painting and reorganization as well as need for better furniture (Plate 12). The office of the Scheme Manager was in a uniport and the District Water Officer/Operations Manager was using the main office.

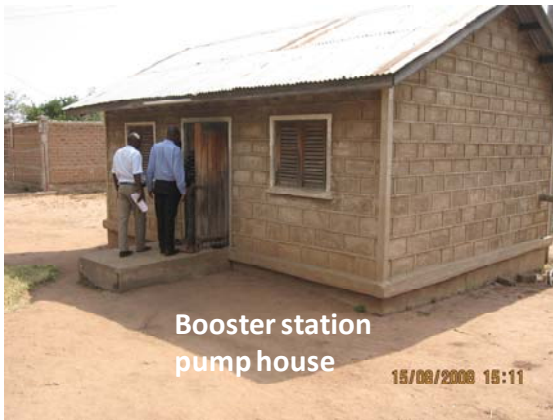
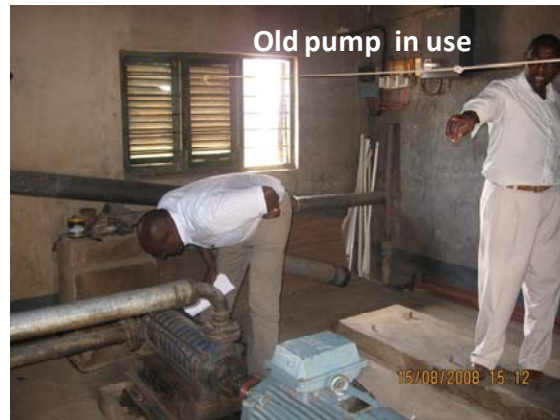
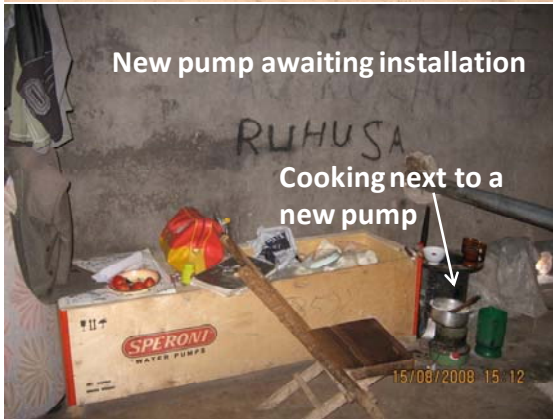
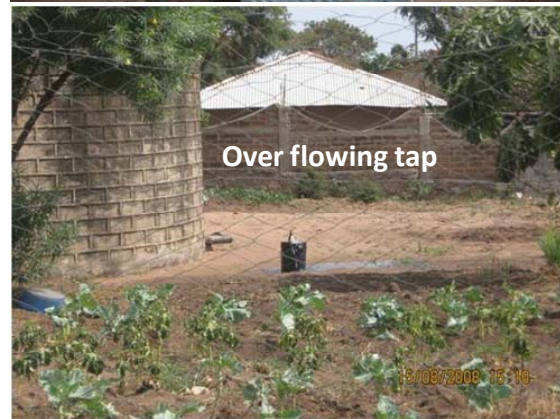
Plate 23: Ushashi Booster Station

The drinking water supply situation in Bunda town can only be described as inadequate. The service level in Bunda is insufficient with low pressures, frequent supply interruptions, high levels of NRW, high energy costs and poor water quality. The water pumping stations at Guta, Migungani and Ushashi are in a fair state and with some rehabilitation should be able to work well. There were no preventive maintenance records seen at any of the stations nor at the head office. This is likely to affect performance of the assets in the long run. This indicates that no planned preventive maintenance system is in place. It is not possible to accurately compute NRW figures due to low levels of metering and inadequate billing system to generate required revenue water data. The distribution network was delivering water at very low pressures on a few visited sites and most places were not receiving water. There were no records of pipe bursts and leaks to give an indication of the condition of the network.
